Recent UNILAC Upgrade Activities

*Winfried Barth, Uwe Scheeler, Maksym Miski-Oglu,
Hartmut Vormann, Markus Vossberg, Stepan Yaramyshev*
Linac department, GSI Darmstadt

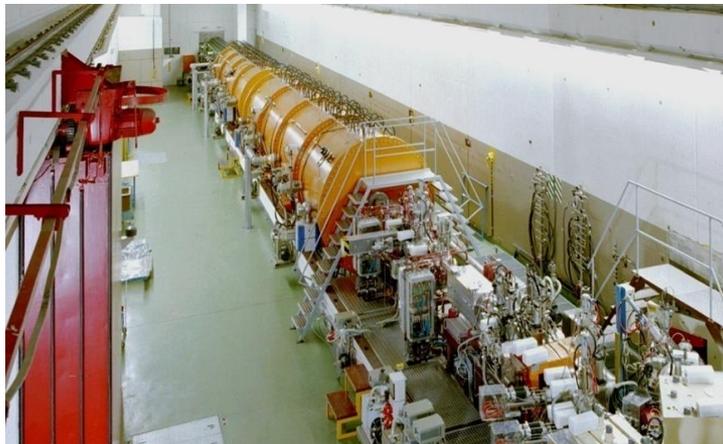
High Current Injector

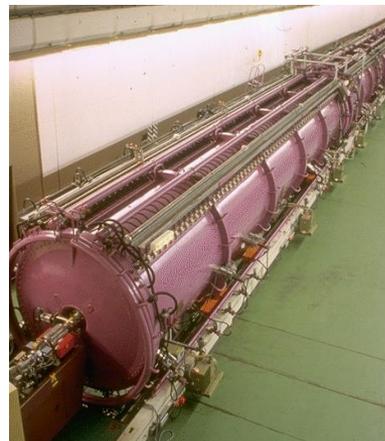
Alvarez cavities

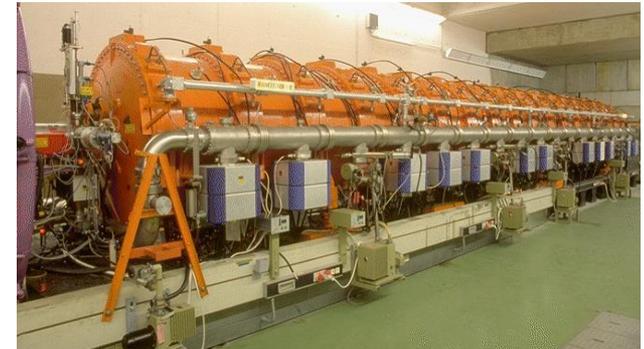
Single gap resonators

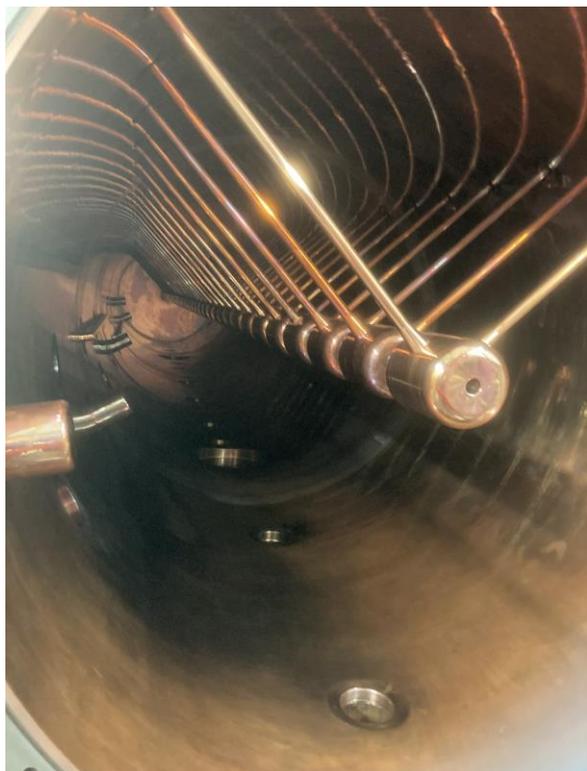
cavity inside

- The five Alvarez cavities are equipped with 176 drift tubes
- A little less than one defect per year occurred in the past
- In case of a defect operation can be continued with restrictions
- Concerning fabrication two types are in use (body consists of full copper or double walled stainless steel)

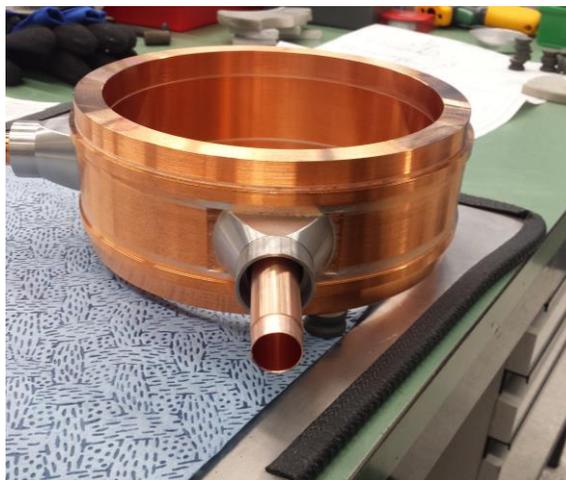
shell of the copper version

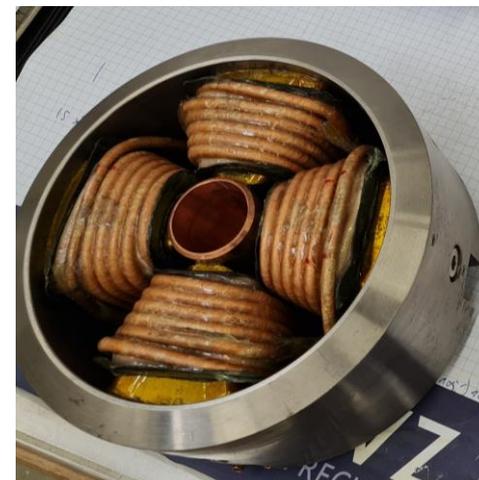
*inner yoke with
magnet coils*

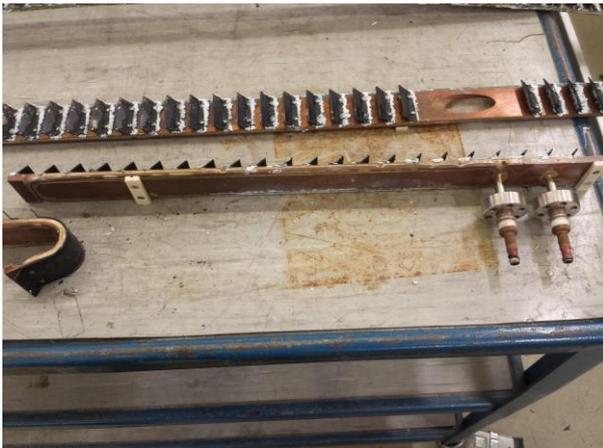
defect baffle plates with corrosion

- Often water leaks are responsible for serious vacuum failures
- The bending radius of the cooling pipes has been increased in order to reduce cavitation and the electrical isolation of the fastening has been removed to simplify the construction
- The rectangular feed through flange is difficult to seal
- Careful monitoring of the vacuum pressure is organized in order to avoid serious damage of any cooled component due to water leaks

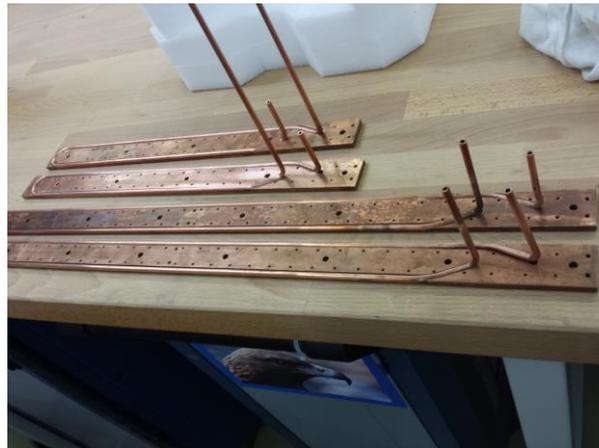
fabrication of new cooling channels

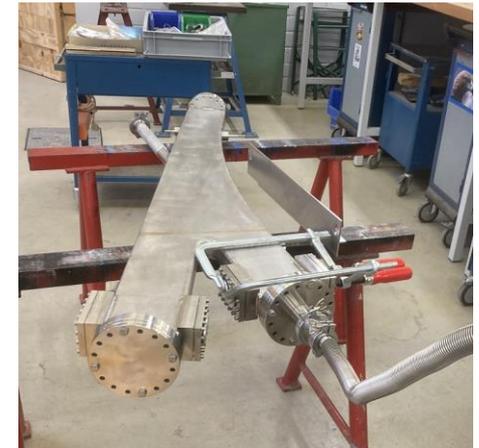
final vacuum test

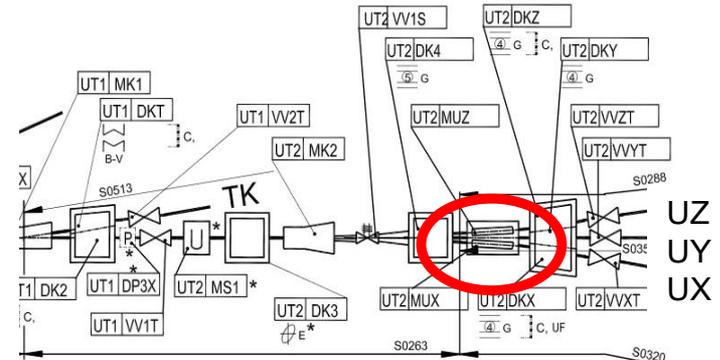
sketch of beamline in front of experimental hall

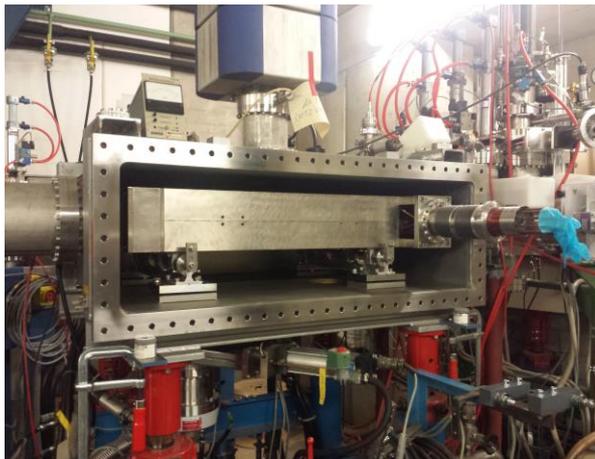
open vacuum chamber with right septum magnet

- In case of any defect the repair of the coils (installed in vacuum) is difficult and time consuming
- The tight structure and complex construction has to be handled
- Three septa together have been in operation for little less than 50 years
- Last spare part is irreparable due to a ground fault of the coil, the fabrication of new coils has been started

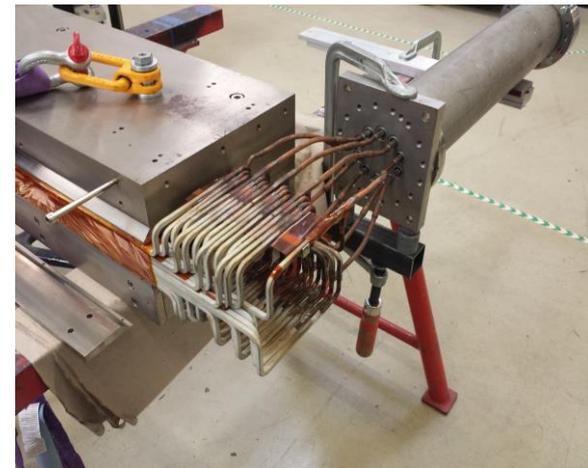
water and current supply of the single coil windings

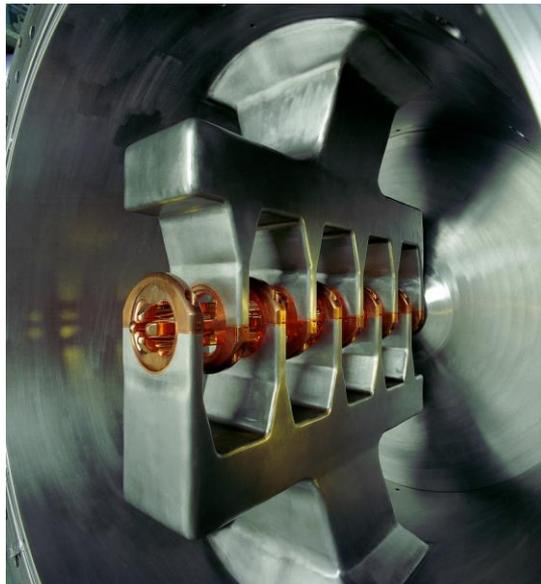
superlens

- Next step: exchange of superlens rods after 18 years operation
- Long term task: increase aperture and focusing strength of quadrupoles and superlens

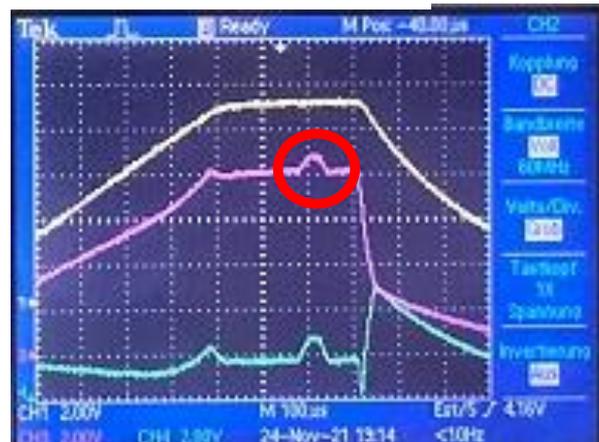
RF amplitude (yellow) and RF power signal (magenta): additional power needed during beam pulse

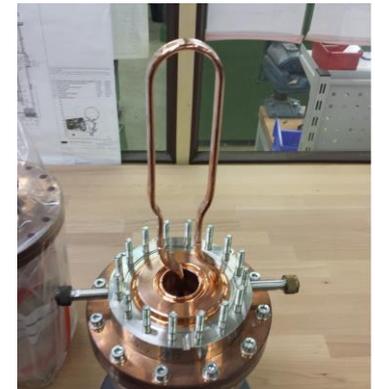
the coupling of the cavity could not be significantly improved by exchange of coupling loop in 2021

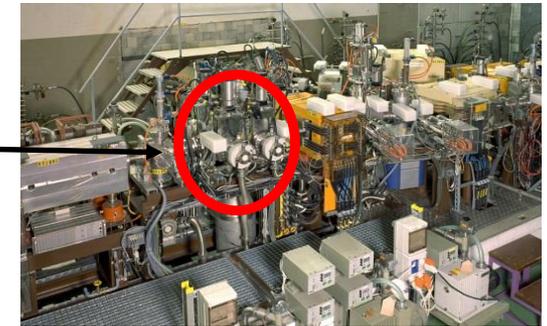
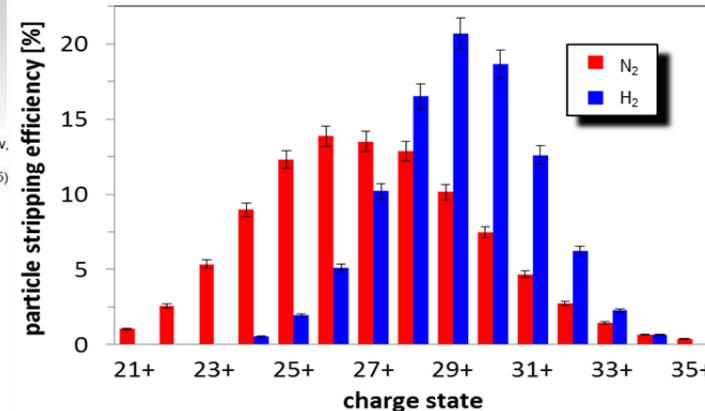
charge distribution for Uranium beam

- Main step to higher uranium intensity is related to pulsed gas stripper operation with Hydrogen

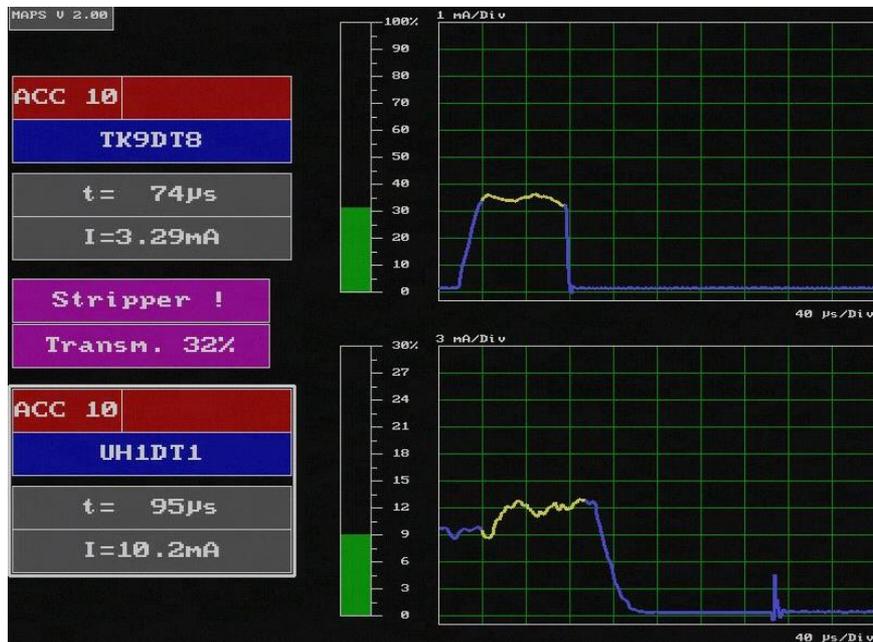
transmission control V.a (pulse shape)

- Beam intensity measurements are performed by beam transformers since many years
- The observation of the pulse shape is needed to survey the stability of all devices during the beam pulse
- In order to handle intensity fluctuations the measurement of all transformers has to be performed in the same pulse along the whole accelerator

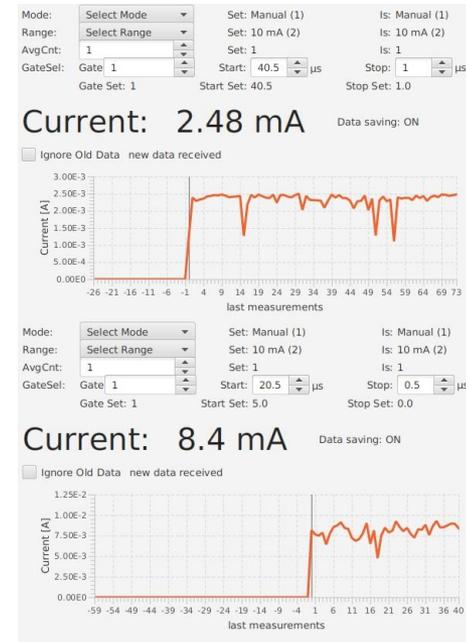
transmission control V.b (trending)

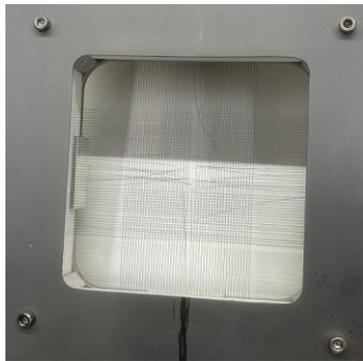
SEM grid with defective wires

- SEM grids are used at UNILAC widely
- An increased damage rate for SEM grids have been observed in the recent past, even so we have a protection system
- Reduced pulse duration and repetition rate can only be performed to a technical minimum
- The BIF (beam induced fluorescence) system has to be optimized to provide the same quality of the measurement data

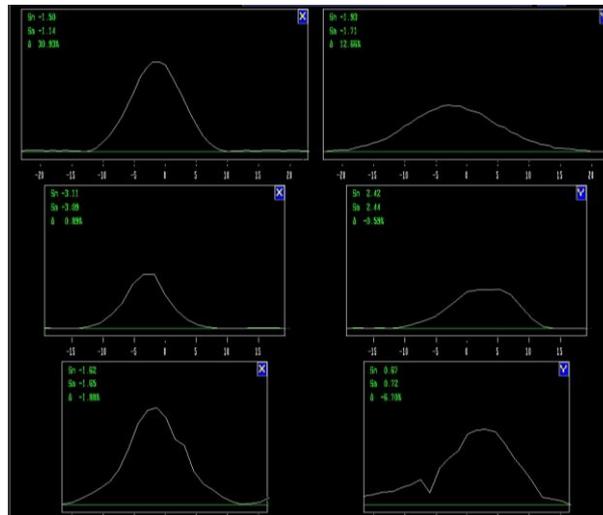
beam profiles (SEM grid)

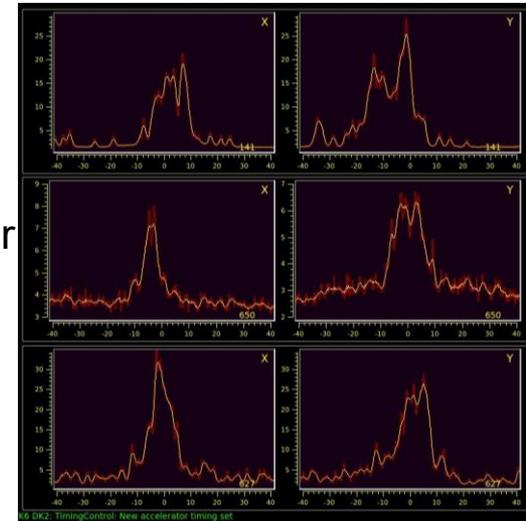
beam profiles (BIF)
